Manhole Inspection Summary

Manhole # S15I__013MH

Inspection ☐ Is Incomplete Rating: **3) Fair**

Location Address: **2 franklintown rd**

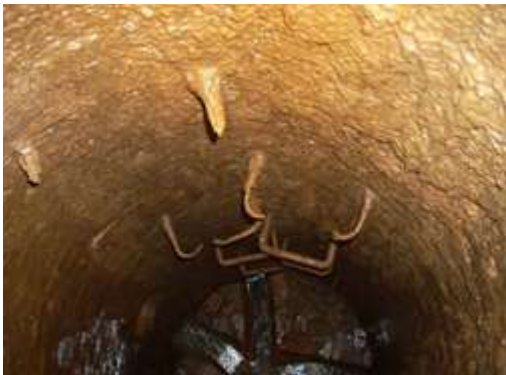
Defect 3

Count: **5** Missing: **3** ☒ **Corroded**

corbel parged, corroded and missing steps

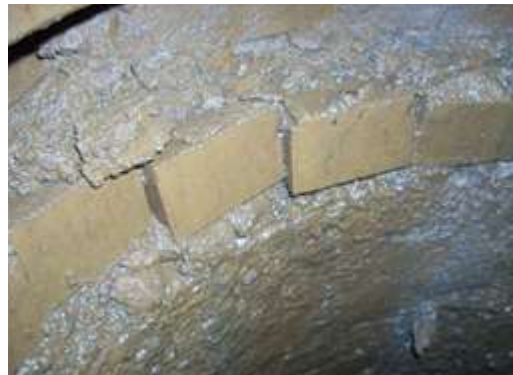
Defect 2

Condition: ☐ Sound ☐ Cracked ☐ Root Intrusion ☒ **Loose Brick** ☐ Deteriorated

loose chimney bricks

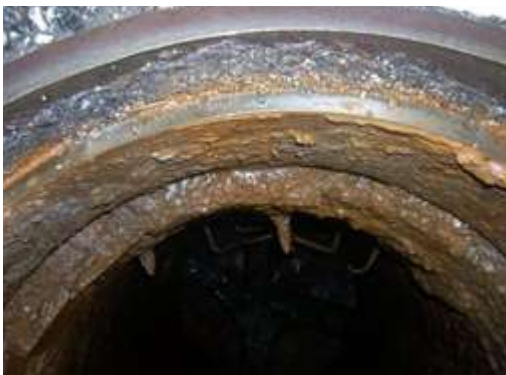
Defect 1

Offset: **2** (in.)

frame offset

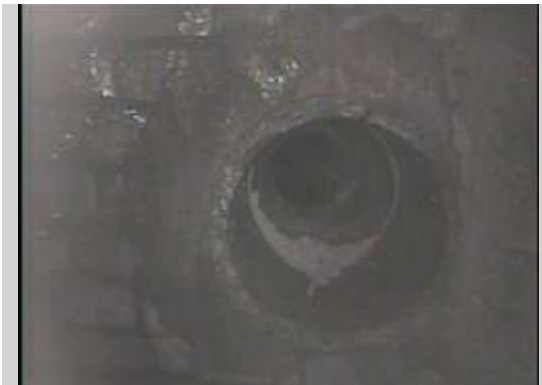
3 O'Clock Inflow

Pipe Height: **8.4** (in.) Rod and Bar (Angled)
Pipe Material: **Clay** ☐ Pipe Lined
Invert Depth: **7.92** (ft.) Flow Characteristics: **Slow**
Deposits: ☒ None ☐ Mud ☐ Sludge ☐ Debris ☐ Grease
Silt Depth: **0** (in.) Deposits Extent:
Infiltration: **None** Pipe Seal Cond: **Broken**

Drop: **Outside** Rod and Bar
Angled: **Yes** Reading: **11.61** (ft.)
Inv Depth: **12.61** (ft.)

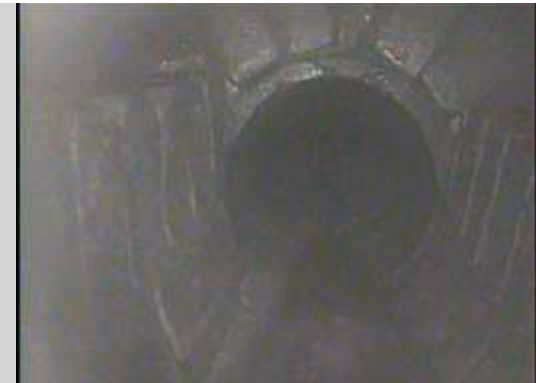
9 O'Clock Inflow

Infiltration: **Evidence** Pipe Seal Cond: **Sound**
